**Flood Control Project Maintenance  
Levee Inspections**

**Fall 2018 Levee Maintenance Deficiency Summary Report**

**Sacramento River Basin**

| <b>RD0536</b> | Overall LMA Rating | Total LMA Miles | | | | | | |
|---|---|---|---|---|---|---|---|---|
| <b>Reclamation District No. 0536 Egbert</b> | <b>U</b> | <b>10.59</b> | | | | | | |

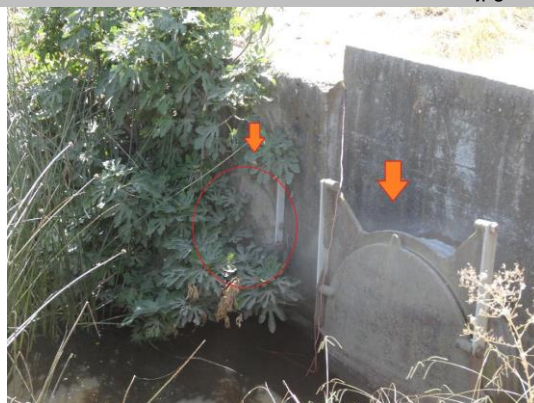
Photo 1 of 3 : UCIP\_FA\_2018\_53359\_34457.jpg

| FS_ID:53359<br>DS_ID:22712<br>EP_NO: 10114<br>Repair Type: Urgent<br>Crossing Status: Found<br>UCIP Comments: 10/2/2018 Holes present in pipe pose internal levee threat; keeping as Urgent (D. Sanoski - DWR UCIP).06/01/2016: Holes and heavy corrosion inside pipe on WS have gotten worse. Flapgates appear in good condition though vegetation blocks view of flapgate for 36-inch on WS. These pipes are still in use and necessary for drainage; pipes may be eligible for repair under DWR Deferred Maintenance Program. (K. Fazel - UCIP)08/13/2013:- Holes in pipe outlet due to heavy corrosion.- Needs detailed investigation of the pipe.- Headwall cracked and tilted on WS. (P. Amatya - DWR)<br>FIELD_STRUCT_DESC: 1 of 2: 60-inch corrugated metal gravity drainage pipe through the levee, 10 feet below the crown. Flap gate on the waterside (WS). Headwall on each end. Culverts run under the road to provide drainage from agricultural fields via a landside (LS) ditch to Lindsey Slough. No. 100 gate in the LS drainage ditch. Reclamation District No. 536 (RD0536) president is David Hearn at heardnd5@gmail.com. (Retention of one 60-inch and one 36-inch drainage pipes through the levee, 10 feet and 6.5 feet below the crown, respectively, and flap gates on the WS ends authorized under Automatic Board Order (ABO) issued as Permit No. 10114, 1974 - H. E. Peterson). [Additional Reference(s): DWR Levee Log, 1992. USACE Sacramento O&M Manual 106, May 1953, (Station 294+49 "'A'"), invert elevation 14.4 feet].<br>FS Date: 10/2/2018 1:53:00 PM | | | | | | |

WS view: two CMPs with flap gates. Concrete headwall supports the pipes. A 36" CMP (left) and 60" CMP (right).

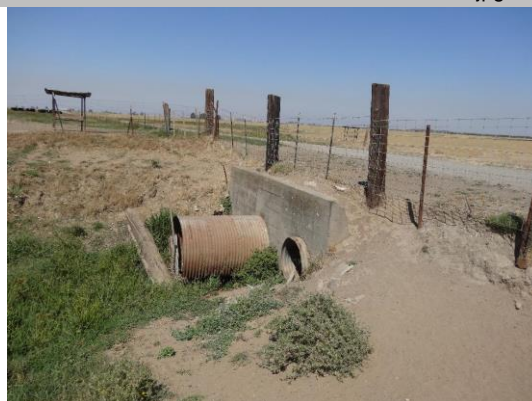
Photo 2 of 3 : UCIP\_FA\_2018\_53359\_34456.jpg

LS view: two inlet CMPs with flap gates. Concrete headwall supports the pipes. A 36" CMP (right) and 60" CMP (left).

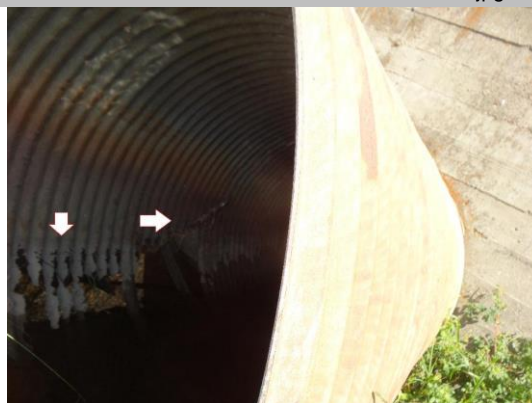
Photo 3 of 3 : UCIP\_FA\_2018\_53359\_34455.jpg

| FS_ID:53359<br>DS_ID:22712<br>EP_NO: 10114<br>Repair Type: Urgent<br>Crossing Status: Found<br>UCIP Comments: 10/2/2018 Holes present in pipe pose internal levee threat; keeping as Urgent (D. Sanoski - DWR UCIP).06/01/2016: Holes and heavy corrosion inside pipe on WS have gotten worse. Flapgates appear in good condition though vegetation blocks view of flapgate for 36-inch on WS. These pipes are still in use and necessary for drainage; pipes may be eligible for repair under DWR Deferred Maintenance Program. (K. Fazel - UCIP)08/13/2013:- Holes in pipe outlet due to heavy corrosion.- Needs detailed investigation of the pipe.- Headwall cracked and tilted on WS. (P. Amatya - DWR)<br>FIELD_STRUCT_DESC: 1 of 2: 60-inch corrugated metal gravity drainage pipe through the levee, 10 feet below the crown. Flap gate on the waterside (WS). Headwall on each end. Culverts run under the road to provide drainage from agricultural fields via a landside (LS) ditch to Lindsey Slough. No. 100 gate in the LS drainage ditch. Reclamation District No. 536 (RD0536) president is David Hearn at hearnd5@gmail.com. (Retention of one 60-inch and one 36-inch drainage pipes through the levee, 10 feet and 6.5 feet below the crown, respectively, and flap gates on the WS ends authorized under Automatic Board Order (ABO) issued as Permit No. 10114, 1974 - H. E. Peterson). [Additional Reference(s): DWR Levee Log, 1992. USACE Sacramento O&M Manual 106, May 1953, (Station 294+49 "'A'"), invert elevation 14.4 feet].<br>FS Date: 10/2/2018 1:53:00 PM | | | | | | | | | | | | |

LS view: holes & cracks on CM pipe due to heavy corrosion. Needs detailed investigation of the pipe.

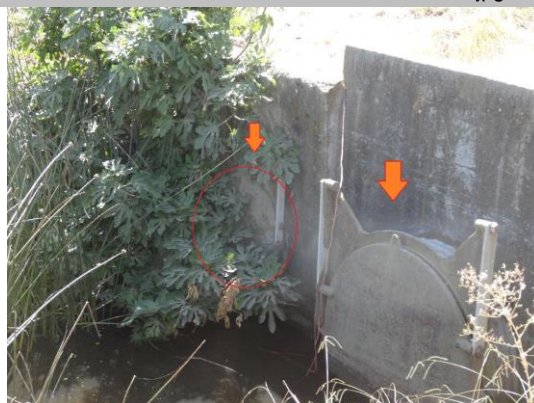
Photo 1 of 3 : UCIP\_FA\_2018\_53360\_34771.jpg

| FS_ID:53360<br>DS_ID:22726<br>EP_NO: 10114<br>Repair Type: Urgent<br>Crossing Status: Found<br>UCIP Comments: 10/2/2018 Vegetation blocked WS view of pipe, though a hole directly above WS inlet pipe could be a sinkhole. Keeping as Urgent and recommend internal inspection due to holes in 60-inch pipe (D. Sanoski - DWR UCIP).06/01/2016 Pipe is not abandoned. Though neglected, it is still functional and a needed system feature. Pipe is severely corroded with holes in it, which are visible on LS. Vegetation blocks view of flapgate on WS. Pipes may be eligible for repair under DWR Deferred Maintenance Program. (K. Fazel - UCIP)08/13/2013 This pipe seems to be abandoned. Headwall cracked and tilted on WS. (P. Amatya)<br>FIELD_STRUCT_DESC: 2 of 2: 36-inch corrugated metal gravity drainage pipe through the levee, 10 feet below the crown. Flap gate on the waterside (WS). Headwall on each end. Culverts run under the road to provide drainage from agricultural fields via a landside (LS) ditch to Lindsey Slough. No. 100 gate in the LS drainage ditch. Reclamation District No. 536 (RD0536) president is David Hearn at hearnd5@gmail.com. (Retention of one 60-inch and one 36-inch drainage pipes through the levee, 10 feet and 6.5 feet below the crown, respectively, and flap gates on the WS ends authorized under Automatic Board Order (ABO) issued as Permit No. 10114, 1974 - H. E. Peterson). [Additional Reference(s): DWR Levee Log, 1992, referenced as 6.5 feet below the crown. USACE Sacramento O&M Manual 106, May 1953, (Station 294+49 ""A""), invert elevation 14.4 feet].<br>FS Date: 10/2/2018 2:10:00 PM | | | | | |

WS view: concrete headwall, flap gates on 36" CMP (left) and 60" CMP (right)

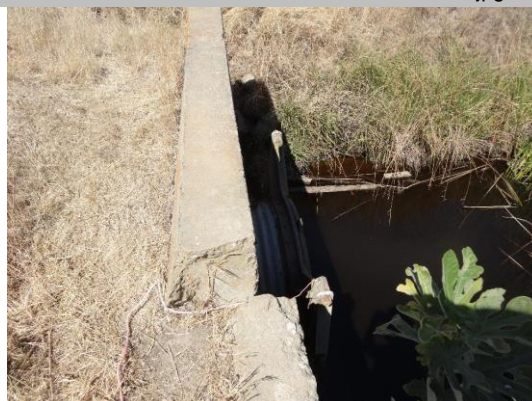
Photo 2 of 3 : UCIP\_FA\_2018\_53360\_34770.jpg

WS view: cracked and tilted concrete headwall.

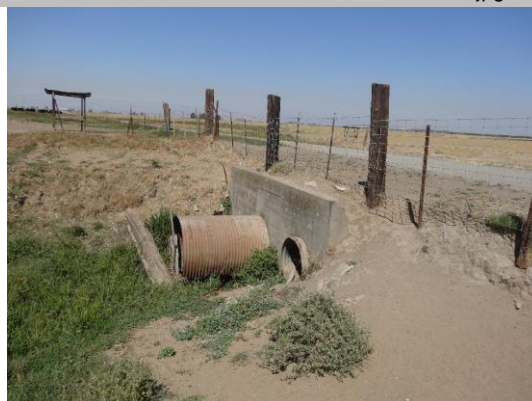
Photo 3 of 3 : UCIP\_FA\_2018\_53360\_34769.jpg

LS view: concrete headwall, 36" CMP (right) and 60" CMP (left)

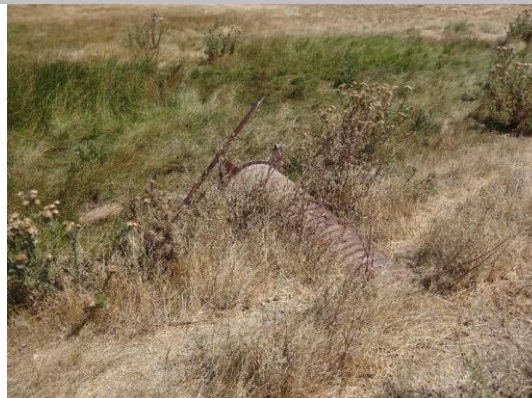
Photo 1 of 3 : UCIP\_FA\_2018\_49313\_34774.jpg

WS view: overview of exposed CM pipe on levee slope.

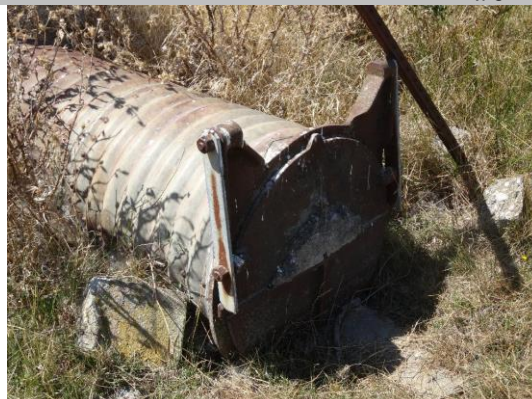
Photo 2 of 3 : UCIP\_FA\_2018\_49313\_34773.jpg

WS view: CM pipe blocked by concrete debris on levee slope.

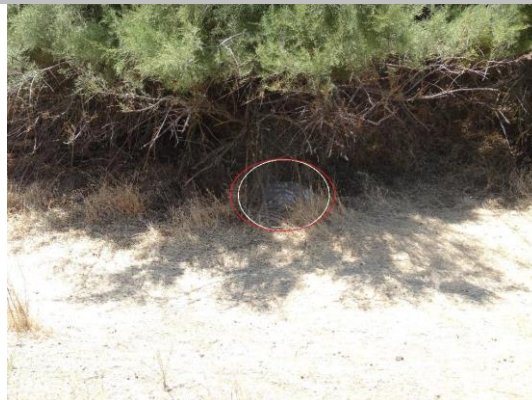
Photo 3 of 3 : UCIP\_FA\_2018\_49313\_34772.jpg

LS view: open CM pipe end on levee slope.

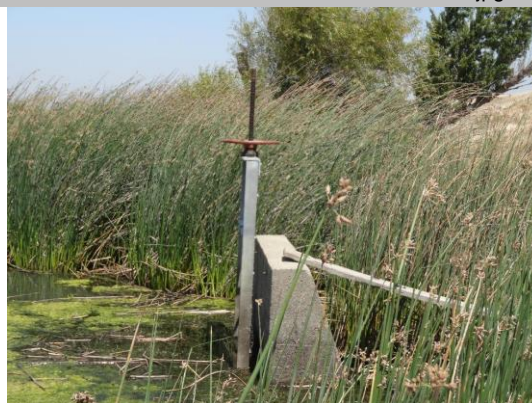
Photo 1 of 2 : UCIP\_FA\_2018\_20444\_34493.jpg

WS view: slide gate, concrete headwall in the channel. Pipe submerged into water.

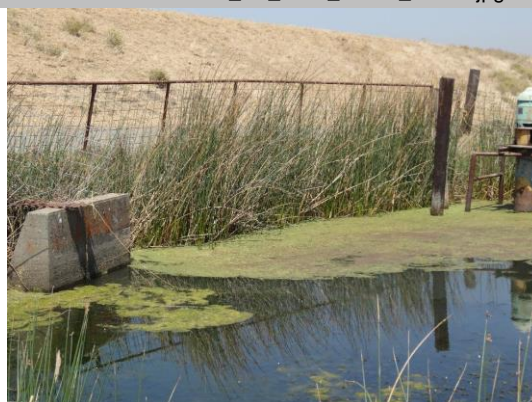
Photo 2 of 2 : UCIP\_FA\_2018\_20444\_34492.jpg

LS view: concrete headwall in the channel/irrigation ditch. Pipe submerged into water.

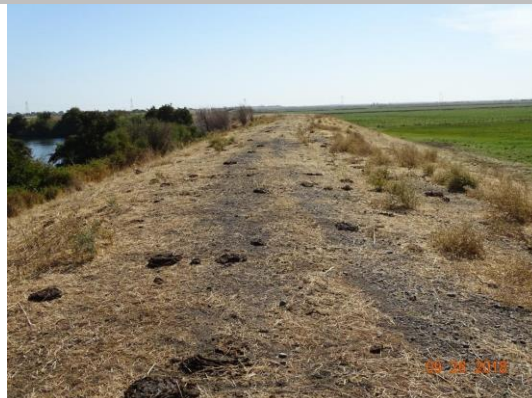
Photo 1 of 1 : FA\_2018\_RD0536\_208\_47\_20180928\_00044.jpg

View looking downstream of the crown. Gravel should be added to the roadway (September 2018).

| C2 : Repair depressions or ruts in the crown or slope. | | | | | |

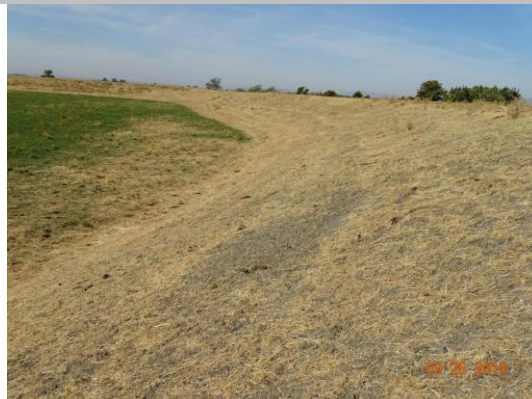
Photo 1 of 2 : FA\_2018\_RD0536\_208\_17\_20180928\_00042.jpg

| Depressions in levee due to cows should be repaired to prevent deeper depressions into levee. | | | | | |

View looking upstream at divots in the slope created by cows. Divots are deep enough that they should be corrected (September 2018).

| S2 : Repair the levee slope damaged by foot traffic and prevent access where possible. | | | | | |

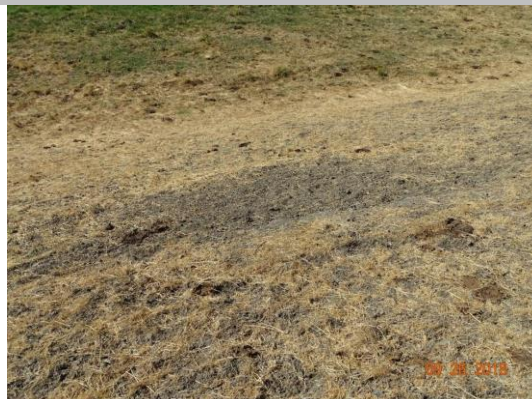
Photo 2 of 2 : FA\_2018\_RD0536\_208\_17\_20180928\_00043.jpg

Looking down slope at one of the cow divots (September 2018).

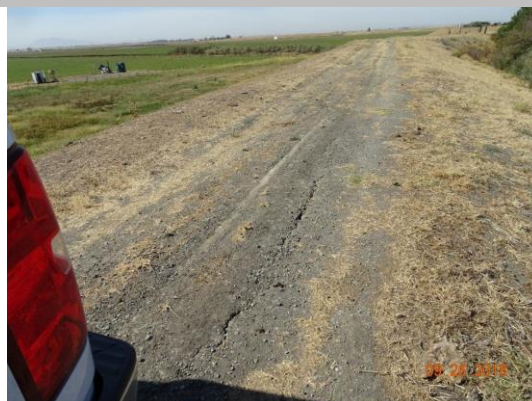
Photo 1 of 1 : FA\_2018\_RD0536\_208\_22\_20180928\_00045.jpg

View looking upstream at the crown. Surface cracks should be fixed and gravel added to roadway (September 2018).

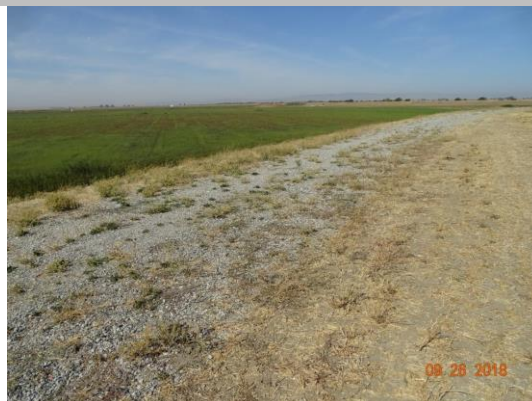
Photo 1 of 2 : FA\_2018\_RD0536\_208\_56\_20180928\_00046.jpg

| Possible subsidence in this area has been repaired. Grade was restored and base rock was added to crown. Area looks good on 3/29/18. Should continue to monitor this site for possible future subsidence. | | | | | |

View looking upstream at minor subsidence. It should be continued to be monitored (September 2018).

| C2 : Repair depressions or ruts in the crown or slope. | | | | | |

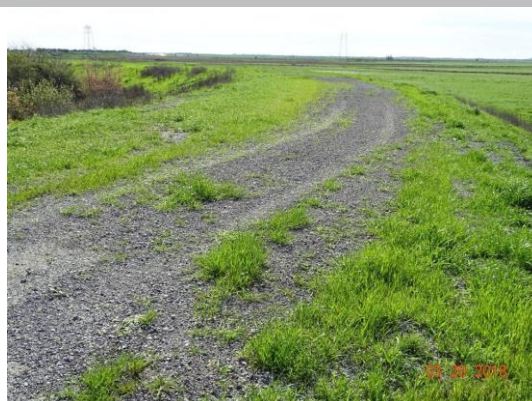
Photo 2 of 2 : FA\_2018\_RD0536\_208\_56\_20180924\_00006.jpg

3/29/2018: Crown rutting and possible subsidence has been repaired, but area should continue to be monitored for possible future subsidence.

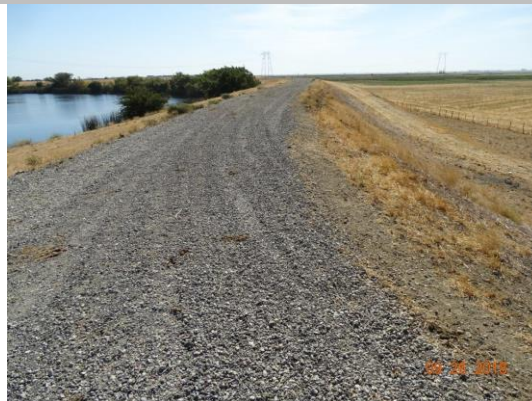
Photo 1 of 2 : FA\_2018\_RD0536\_208\_18\_20180928\_00047.jpg

| No cracks visible. Area should continue to be monitored for future cracking. | | | | | |

View of crown looking downstream with fresh gravel. Cracks are no longer visible (September 2018).

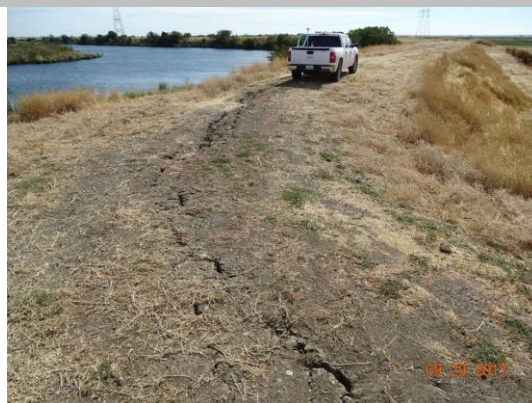
Photo 2 of 2 : FA\_2018\_RD0536\_208\_18\_20180924\_00003.jpg

09/29/2017: Cracks in crown.

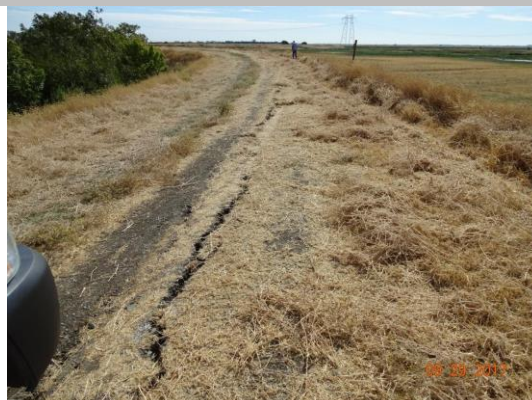
Photo 1 of 1 : FA\_2018\_RD0536\_208\_19\_20180924\_00004.jpg

| No cracks visible. Area should continue to be monitored for future cracking. | | | | | |

09/29/2017: Cracks in crown showing vertical offset with land side lower than most of crown.

| CR2 : Schedule repair of subsidence prior to the next inspection. | | | | | |

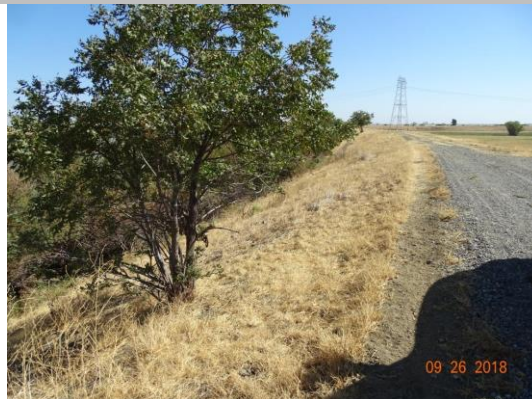
Photo 1 of 1 : FA\_2018\_RD0536\_208\_24\_20180928\_00048.jpg

View looking downstream at walnut trees on the water side crown (September 2018).

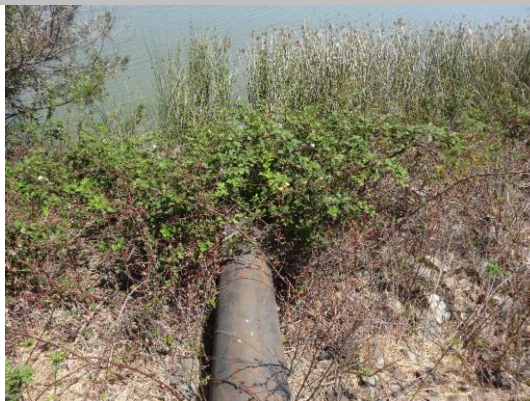
Photo 1 of 3 : UCIP\_FA\_2018\_49314\_34789.jpg

FS\_ID:49314  
DS\_ID:24023  
EP\_NO: N/A  
Repair Type: Non-Urgent  
Crossing Status: Found  
UCIP Comments: 06/01/2016 Could not see flapgate in water. Pipes still in use. No cover over pressure relief valve on WS slope. 08/13/2013:- Field discovered pipe.- Needs more information from the LMA/ DWR Inspector. - Dense vegetation on WS.- Pump feeds both pipes.  
FIELD\_STRUCT\_DESC: 2 of 2: 18-inch steel drainage discharge pipe through the levee, approximately 4 feet below the crown. Pump, called the Buddha Pump, in a pump house on the landside (LS) at the drainage ditch. Pressure breaker on the waterside (WS) slope. Pump and pipes are used by Reclamation District No. 536 (RD0536), per district president David Hearn, but could not identify permit information. Landowner is Dan Hearn per Solano County Assessor's Office (Parcel No. 0042-180-220).  
FS Date: 6/1/2016

WS view: exposed 18" steel pipe on levee slope.

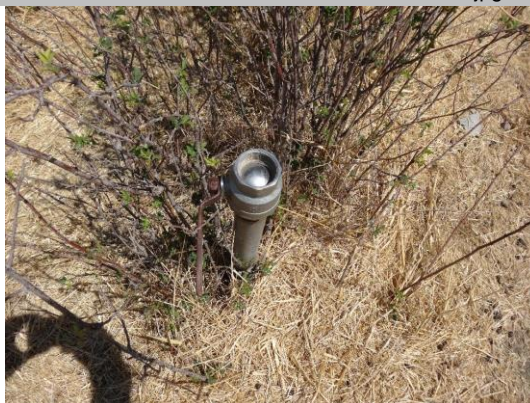
Photo 2 of 3 : UCIP\_FA\_2018\_49314\_34788.jpg

WS view: pressure breaker/valve on levee slope.

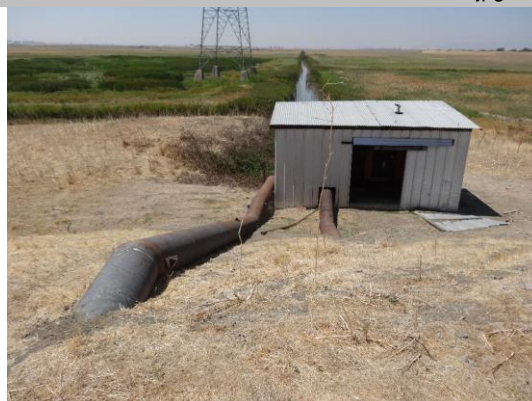
Photo 3 of 3 : UCIP\_FA\_2018\_49314\_34787.jpg

WS view: exposed 18" steel pipe (left) and 16" steel pipe (right) on levee slope. Pump house on bank of drainage ditch.

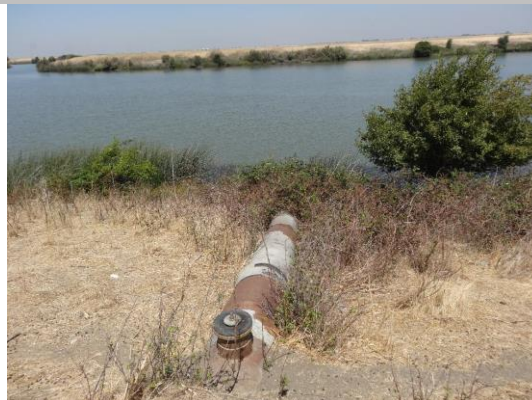
Photo 1 of 3 : UCIP\_FA\_2018\_49317\_34579.jpg

WS view: exposed steel pipe with siphon breaker on levee slope.

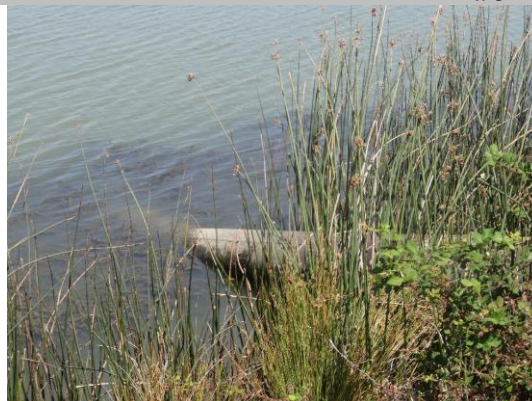
Photo 2 of 3 : UCIP\_FA\_2018\_49317\_34578.jpg

WS view: steel pipe submerged into water in the stream.

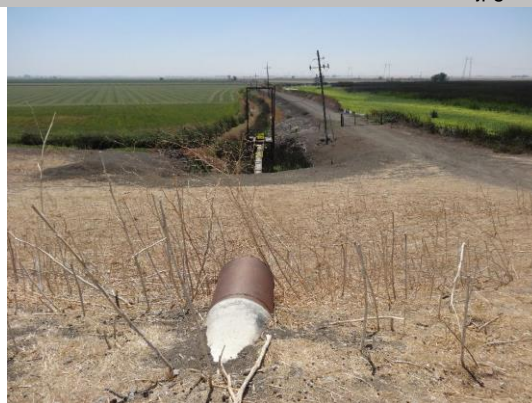
Photo 3 of 3 : UCIP\_FA\_2018\_49317\_34577.jpg

LS view: exposed steel pipe on levee slope and pump deck in drainage ditch.

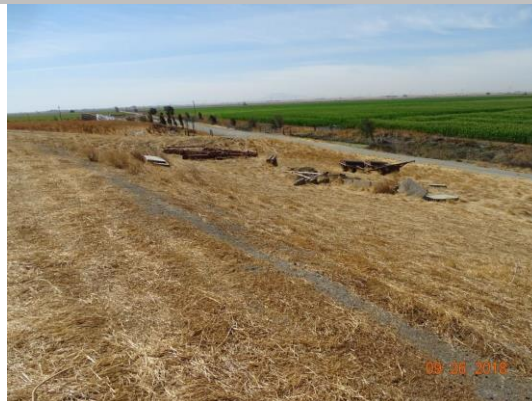
Photo 1 of 1 : FA\_2018\_RD0536\_208\_23\_20180928\_00049.jpg

View looking down slope of farm equipment on the landside slope (September 2018).

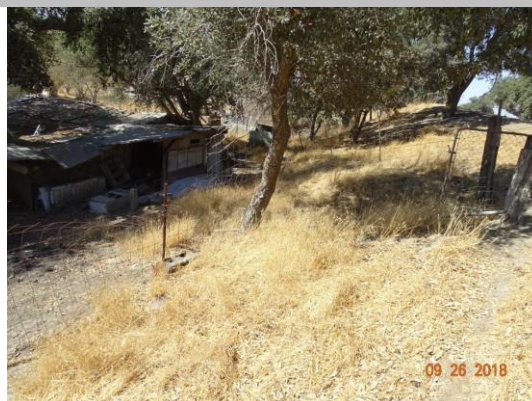
Photo 1 of 2 : FA\_2018\_RD0536\_208\_25\_20180928\_00050.jpg

Fence on the landside slope does not have a permit (September 2018).

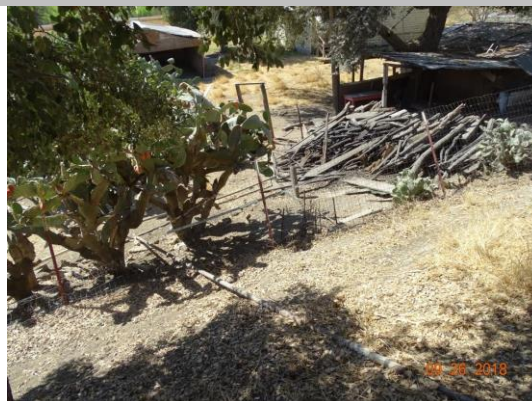
Photo 2 of 2 : FA\_2018\_RD0536\_208\_25\_20180928\_00052.jpg

Cactus, fence, and wood piles at the land side toe (September 2018).

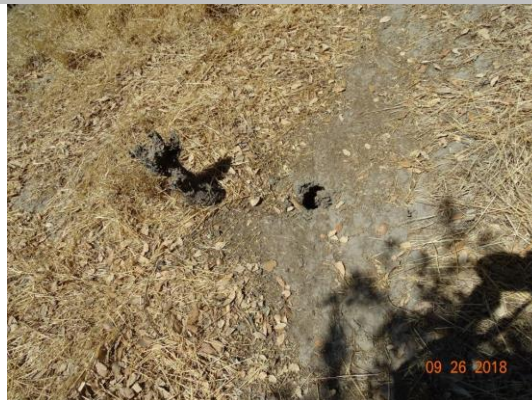
Photo 1 of 1 : FA\_2018\_RD0536\_208\_26\_20180928\_00053.jpg

View of squirrel hole on the land side slope (September 2018).

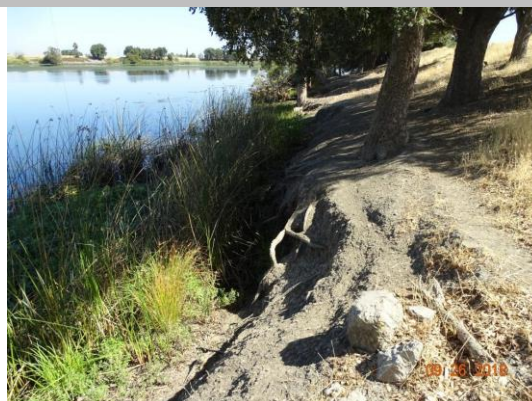
Photo 1 of 1 : FA\_2018\_RD0536\_208\_16\_20180928\_00055.jpg

Deeper erosion at the toe with roots exposed (September 2018).

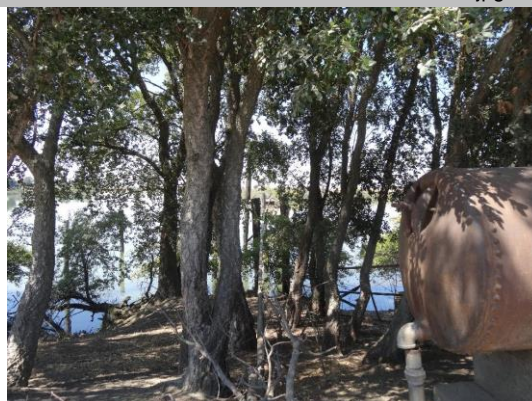
Photo 3 of 3 : UCIP\_FA\_2018\_49318\_34603.jpg

WS view: concrete cradle and abandoned steel tank on levee shoulder.

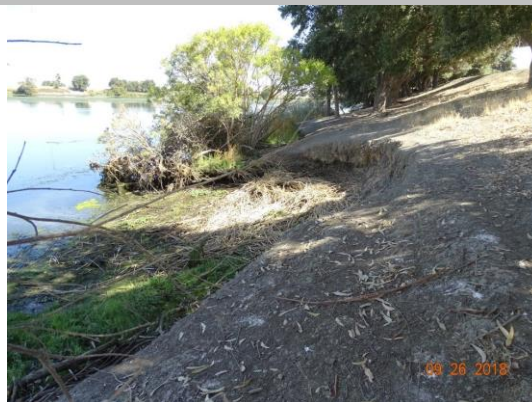
Photo 1 of 1 : FA\_2018\_RD0536\_208\_15\_20180928\_00054.jpg

Large erosion pocket on the water side slope extends deep into slope (September 2018).

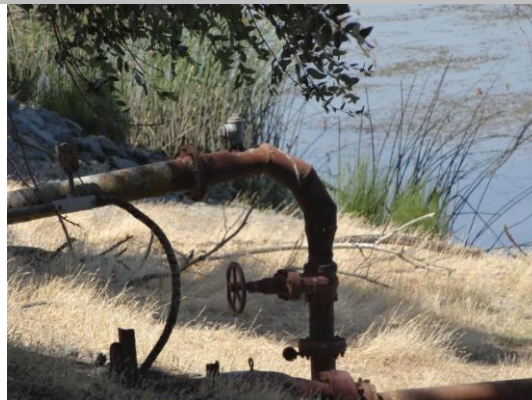
Photo 1 of 2 : UCIP\_FA\_2018\_20543\_34623.jpg

WS view: abandoned pipe, pump, conduit, and gate valve on levee slope.

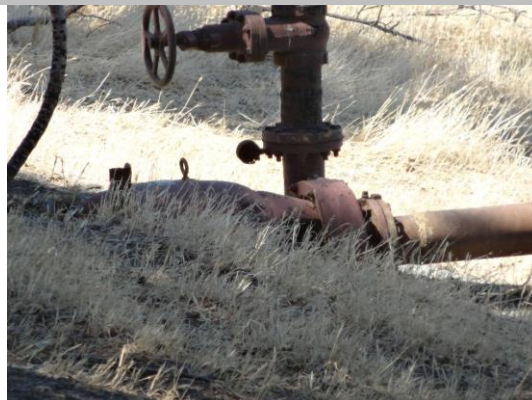
Photo 2 of 2 : UCIP\_FA\_2018\_20543\_34622.jpg

WS view: closer view of abandoned pipe, pump, and gate valve on levee slope.

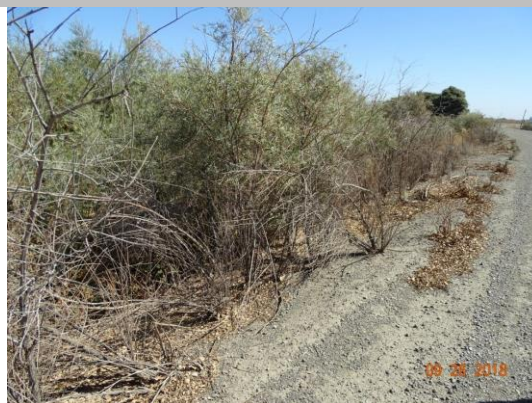
Photo 1 of 1 : FA\_2018\_RD0536\_208\_27\_20180928\_00057.jpg

View of vegetation on the water side up the crown that is blocking visibility (September 2018).

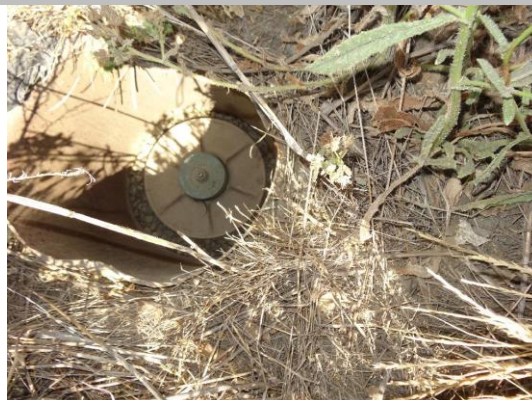
Photo 2 of 3 : UCIP\_FA\_2018\_20563\_34645.jpg

WS view: uncovered siphon breaker on levee shoulder. It needs protection.

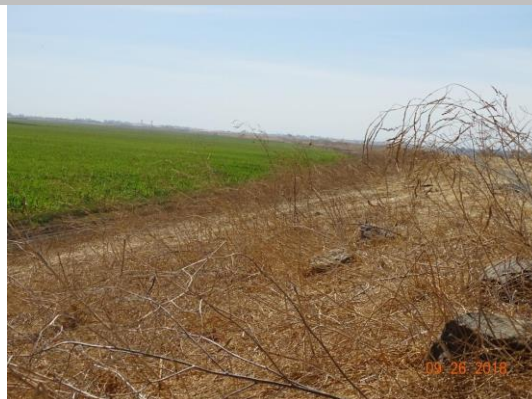
Photo 1 of 1 : FA\_2018\_RD0536\_209\_8\_20180928\_00013.jpg

View looking downstream of the vegetation that is greater than 1 foot and relatively thick (September 2018).

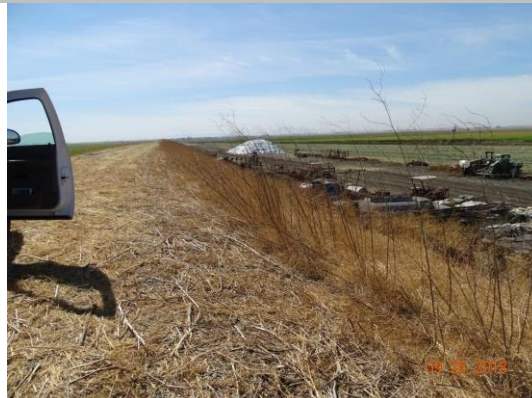
Photo 1 of 1 : FA\_2018\_RD0536\_209\_9\_20180928\_00014.jpg

View looking downstream of relatively thick vegetation greater than 1 foot (September 2018).

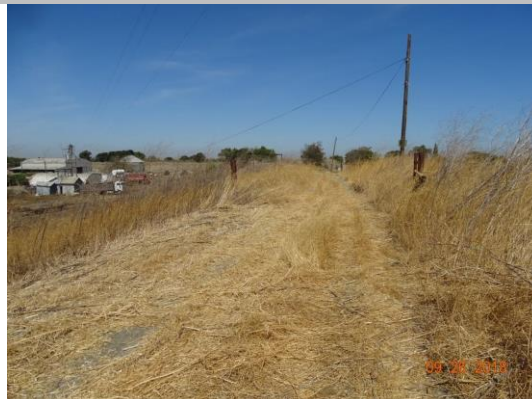
Photo 1 of 1 : FA\_2018\_RD0536\_209\_10\_20180928\_00015.jpg

View looking upstream at vegetation on the crown (September 2018).

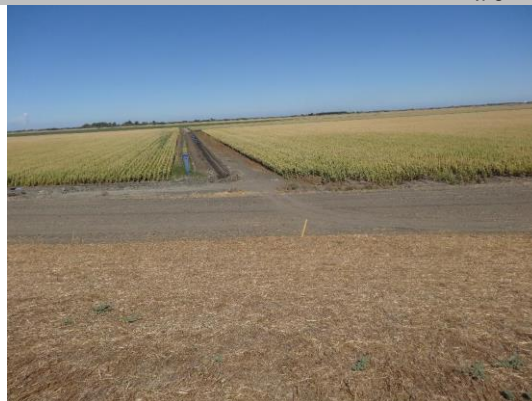
Photo 1 of 3 : UCIP\_FA\_2018\_20664\_34746.jpg

WS view: overview of levee slope and gasoline indicator. The indicator is different than standard indicators.

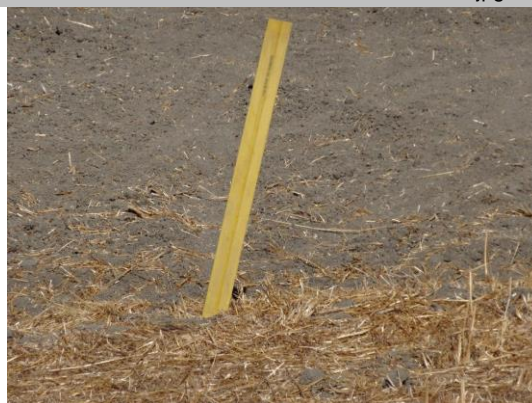
Photo 2 of 3 : UCIP\_FA\_2018\_20664\_34745.jpg

WS view: closer look at gasline indicator. The indicator is different than standard indicators.

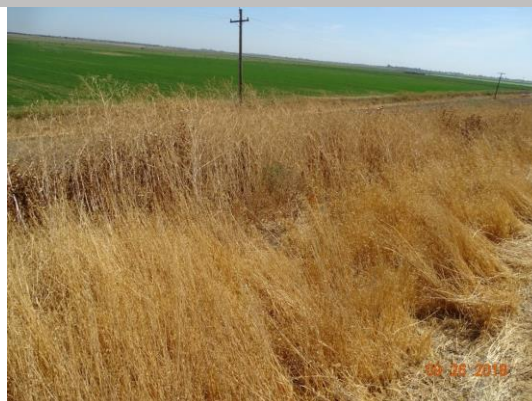
Photo 1 of 1 : FA\_2018\_RD0536\_209\_13\_20180928\_00017.jpg

View looking slightly downstream at thick vegetation all the way up the crown (September 2018).

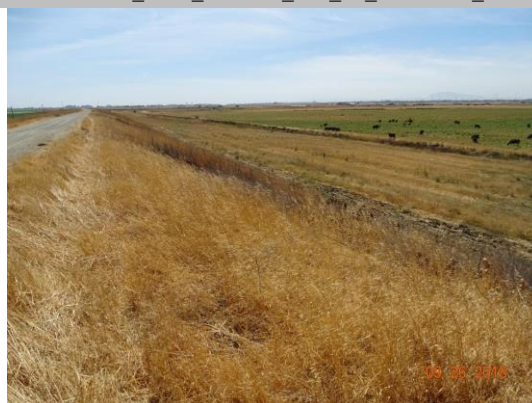
Photo 1 of 1 : FA\_2018\_RD0536\_209\_14\_20180928\_00016.jpg

View looking downstream at vegetation all the way up to the crown (September 2018).
